Illicit Discharge Detection and Elimination Program

Doylestown Township and Citizens

Doylestown Township, Pennsylvania

March 1, 2011

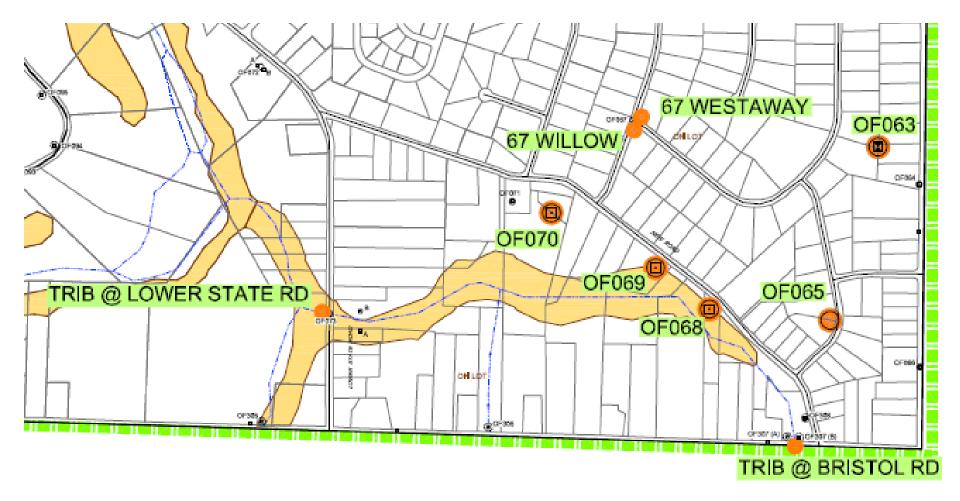
Area 1 Sample Location Map

Area 1

Outfalls

- 8 confirmatory samples at 6 problem outfalls
- Only 1 FC sample >200 col/100 ml
- Maximum FC = 1,100 col/100ml

Stream

- Upstream and Downstream of historical Hot Spots
- Upstream 30 col/100ml
- Downstream 320 col/100ml

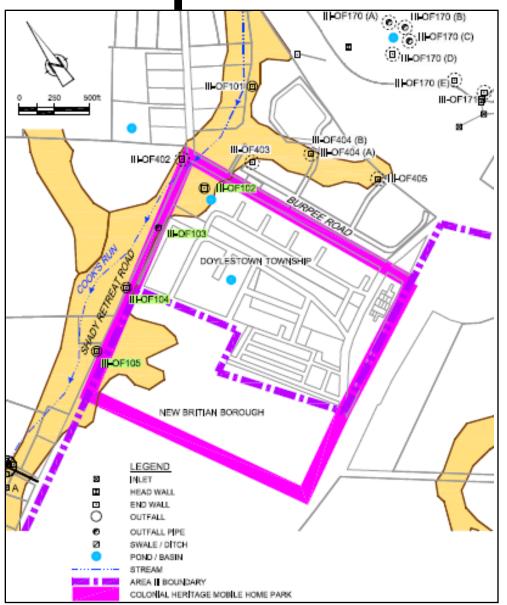
Area 3 Sample Location Map

Area 3 Outfalls

- 2 confirmatory samples at 4 outfalls
- No FC samples >200 col/100ml
