Addendum to Doylestown Township Total Maximum Daily Load Plan (TMDL Plan) and Pollutant Reduction Plan (PRP)

Gilmore and Associates, Inc.
65 East Butler Avenue
New Britain, Pa 18901

Project # 2009078PLN

Date: October 10, 2024

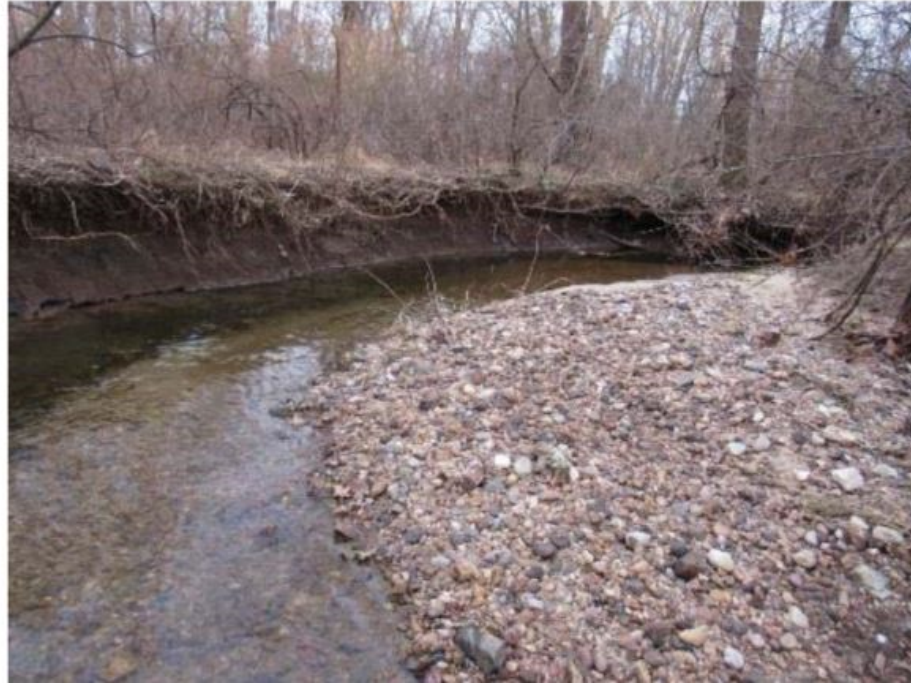
Existing Site Conditions

View looking downstream showing channel migration. The stream bank is vertical with exposed fine grained soil and excessive new gravel deposition of the inside of the meander. Lack of woody riparian zone.

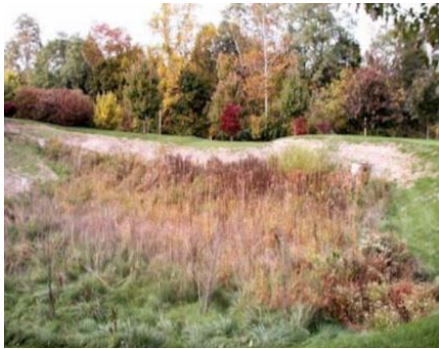
BMP 6.6.3: Dry Extended Detention Basin

A dry extended detention basin is an earthen structure constructed either by impoundment of a natural depression or excavation of existing soil, that provides temporary storage of runoff and functions hydraulically to attenuate stormwater runoff peaks. The dry detention basin, as constructed in countless locations since the mid-1970's and representing the primary BMP measure until now, has served to control the peak rate of runoff, although some water quality benefit accrued by settlement of the larger particulate fraction of suspended solids. This extended version is intended to enhance this mechanism in order to maximize water quality benefits.

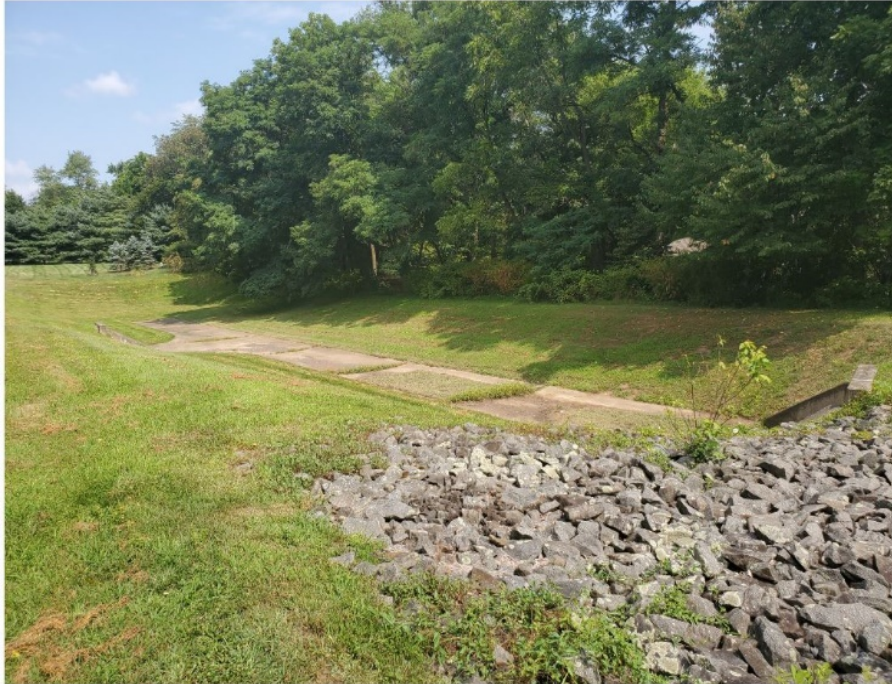
Photo No. 1: Overall Basin

Picture taken 8-3-21

The Township intends to retrofit the existing detention basin through removal of the low flow concrete channel, reconfiguration of the outlet structure to promote recharge and vegetation naturalization.

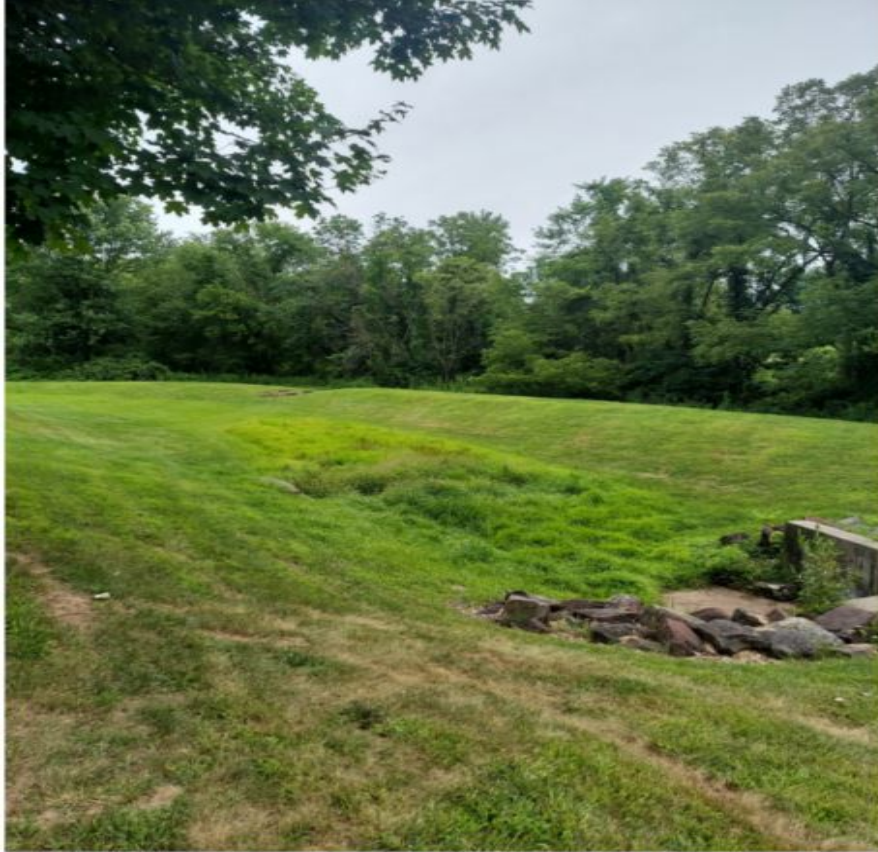
Existing BMP:

Picture taken 8-3-21

The Township intends to retrofit the existing detention basin through reconfiguration of the outlet structure to promote recharge and vegetation naturalization.

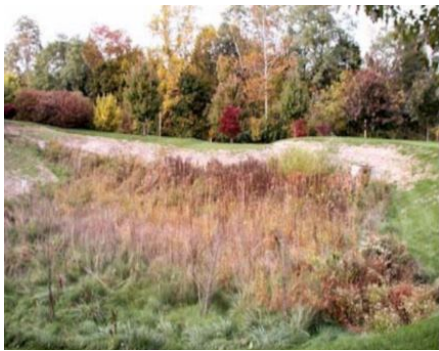
BMP 6.6.3: Dry Extended Detention Basin

A dry extended detention basin is an earthen structure constructed either by impoundment of a natural depression or excavation of existing soil, that provides temporary storage of runoff and functions hydraulically to attenuate stormwater runoff peaks. The dry detention basin, as constructed in countless locations since the mid-1970's and representing the primary BMP measure until now, has served to control the peak rate of runoff, although some water quality benefit accrued by settlement of the larger particulate fraction of suspended solids. This extended version is intended to enhance this mechanism in order to maximize water quality benefits.

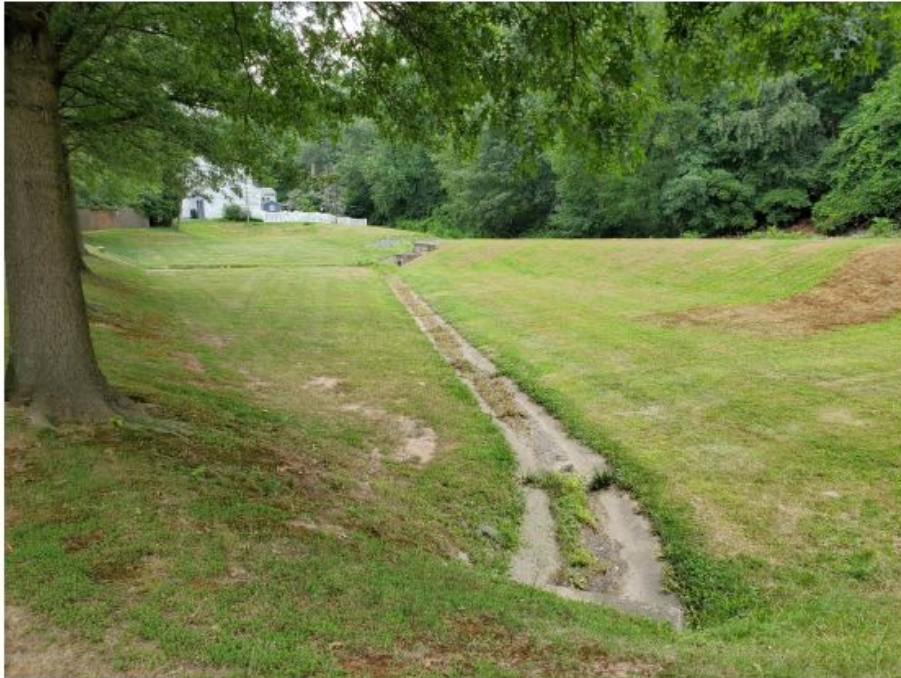
Photo No. 1: Overall Basin

Picture taken 7-29-21

Update: Inspection 6-03-24 – Basin continues to naturalize. Maintenance needed – Remove invasive species in the basin as they appear, remove yard waste, monitor degrading area of outfall structure, mow herbaceous and undesired woody vegetation 1x per year to reduce growth of woody invasives.

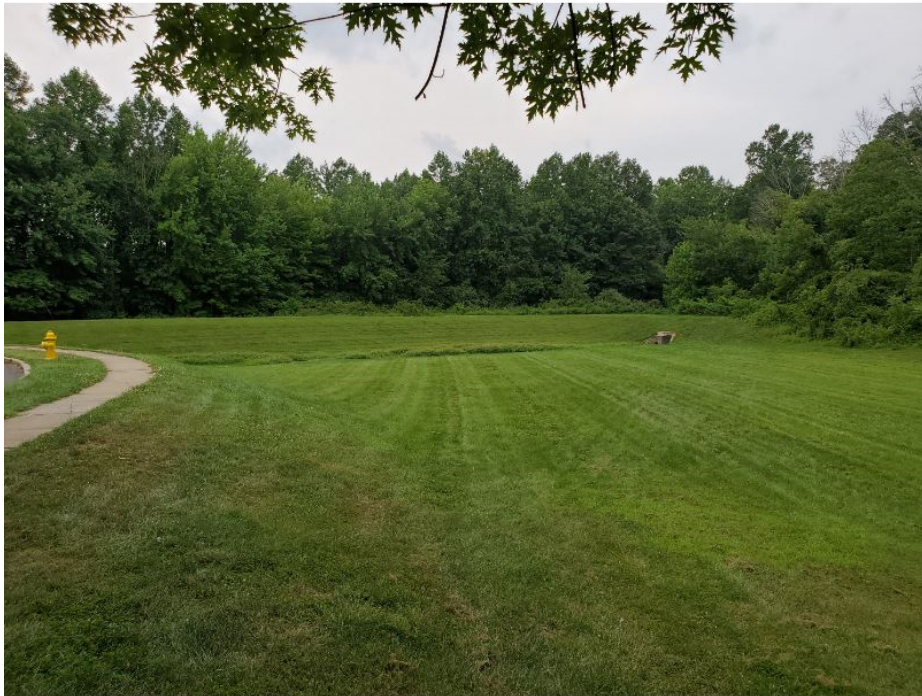
Photo No. 1: Overall Basin

Picture taken 7-29-21

Update: Inspection 6-03-24 – Basin continues to naturalize. Maintenance needed – Replenish riprap at outfall to reduce scour and erosion, remove vegetation and fallen trees blocking outfall access, remove vines encroaching outfall, remove sapling from infall 1, repair any damage to infall structure, remove invasive and aggressive species, remove yard waste, mow herbaceous and undesired woody vegetation

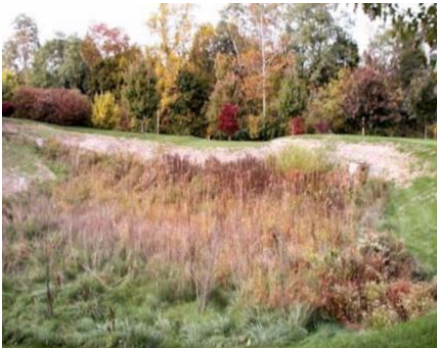
BMP 6.6.3: Dry Extended Detention Basin

A dry extended detention basin is an earthen structure constructed either by impoundment of a natural depression or excavation of existing soil, that provides temporary storage of runoff and functions hydraulically to attenuate stormwater runoff peaks. The dry detention basin, as constructed in countless locations since the mid-1970's and representing the primary BMP measure until now, has served to control the peak rate of runoff, although some water quality benefit accrued by settlement of the larger particulate fraction of suspended solids. This extended version is intended to enhance this mechanism in order to maximize water quality benefits.

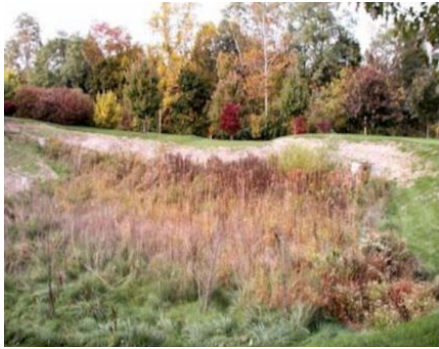
BMP 6.6.3: Dry Extended Detention Basin

A dry extended detention basin is an earthen structure constructed either by impoundment of a natural depression or excavation of existing soil, that provides temporary storage of runoff and functions hydraulically to attenuate stormwater runoff peaks. The dry detention basin, as constructed in countless locations since the mid-1970's and representing the primary BMP measure until now, has served to control the peak rate of runoff, although some water quality benefit accrued by settlement of the larger particulate fraction of suspended solids. This extended version is intended to enhance this mechanism in order to maximize water quality benefits.

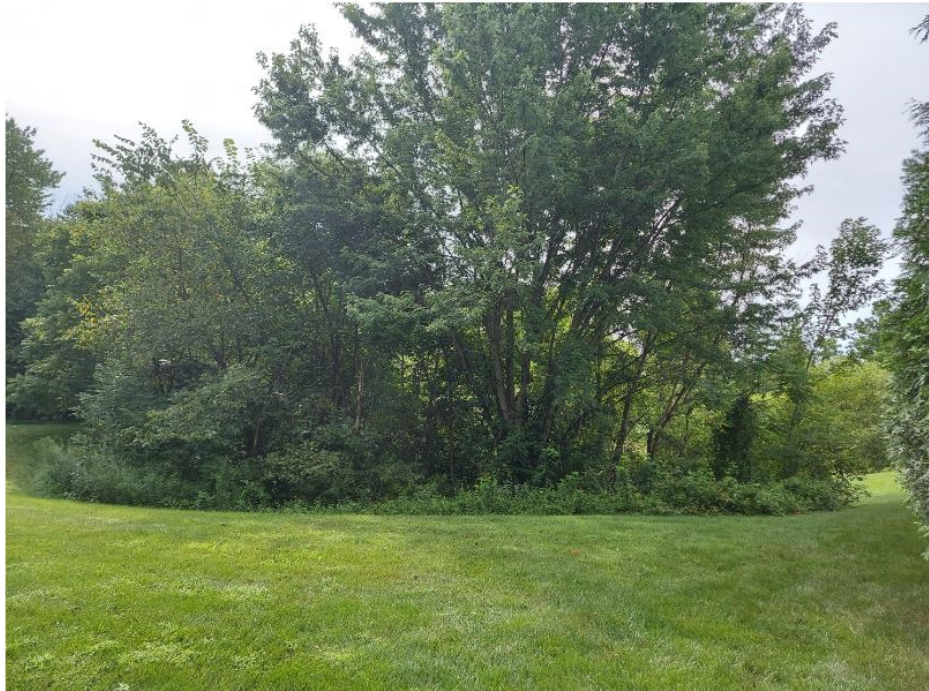
Photo No. 1: Basin Overall

Picture taken 8-3-21

Update: Inspection 6-25-24 – Basin continues to naturalize. Maintenance needed – Remove trees encroaching infalls 1 and 2 and outlet structure. Monitor erosion behind infall 2 wingwall and repair. Replenish rip rap at outfall to reduce scour. Remediate basin as needed to allow basin to function properly and drain. Mow herbaceous and undesired woody vegetation 1x per year to reduce growth of woody invasives. Remove invasive and aggressive species. Monitor concrete deterioration of outfall. Removed trash and yard waste from basin.

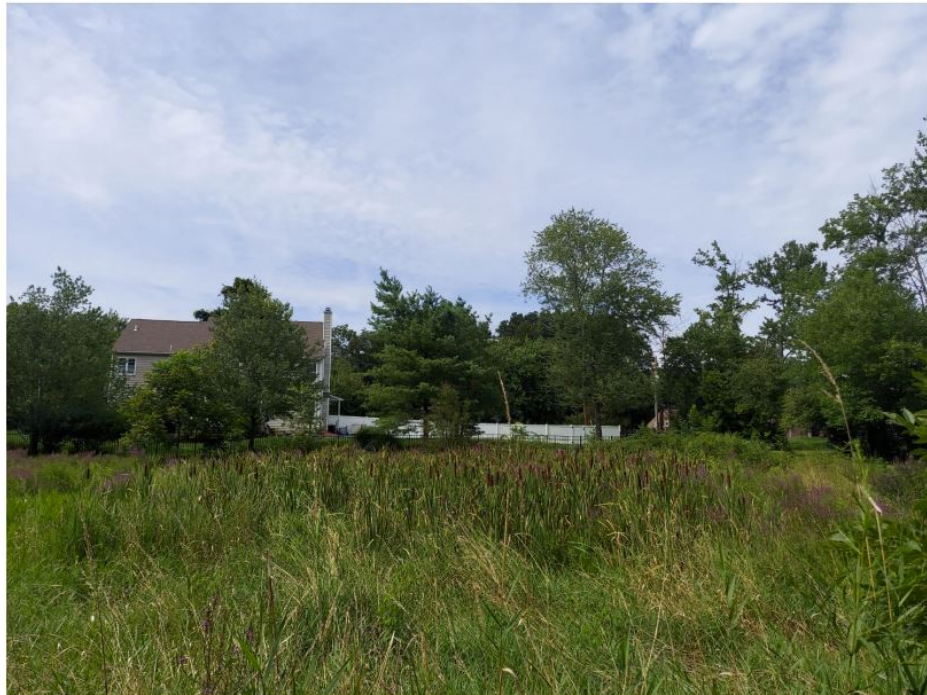
Photo No. 5: Basin Overall

BMP Description: Sheridan Road Basin
Location: Sheridan Road
Lat/Long: 40°16'48", -75°06'58"
BMP type: Dry Extended Detention Basin

Picture taken 8-3-21

Update: Inspection 4-22-244 – Basin continues to naturalize. Maintenance needed – Remove trees encroaching infalls 1 and 2 and outlet structure. Remediate basin as needed to allow basin to function properly and drain. Mow herbaceous and undesired woody vegetation 1x per year to reduce growth of woody invasives. Remove invasive and aggressive species. Remove trash and yard waste from basin.
